PLANNING ASSISTANCE TO STATES (PAS) –  
LITTORAL ANALYSIS AND SEDIMENT BUDGET STUDY  
THE VILLAGE OF GRAND BEACH, MI

GREAT LAKES HYDRAULICS AND HYDROLOGY OFFICE,  
U.S. ARMY CORPS OF ENGINEERS (USACE), DETROIT, MI.

APRIL 1, 2010

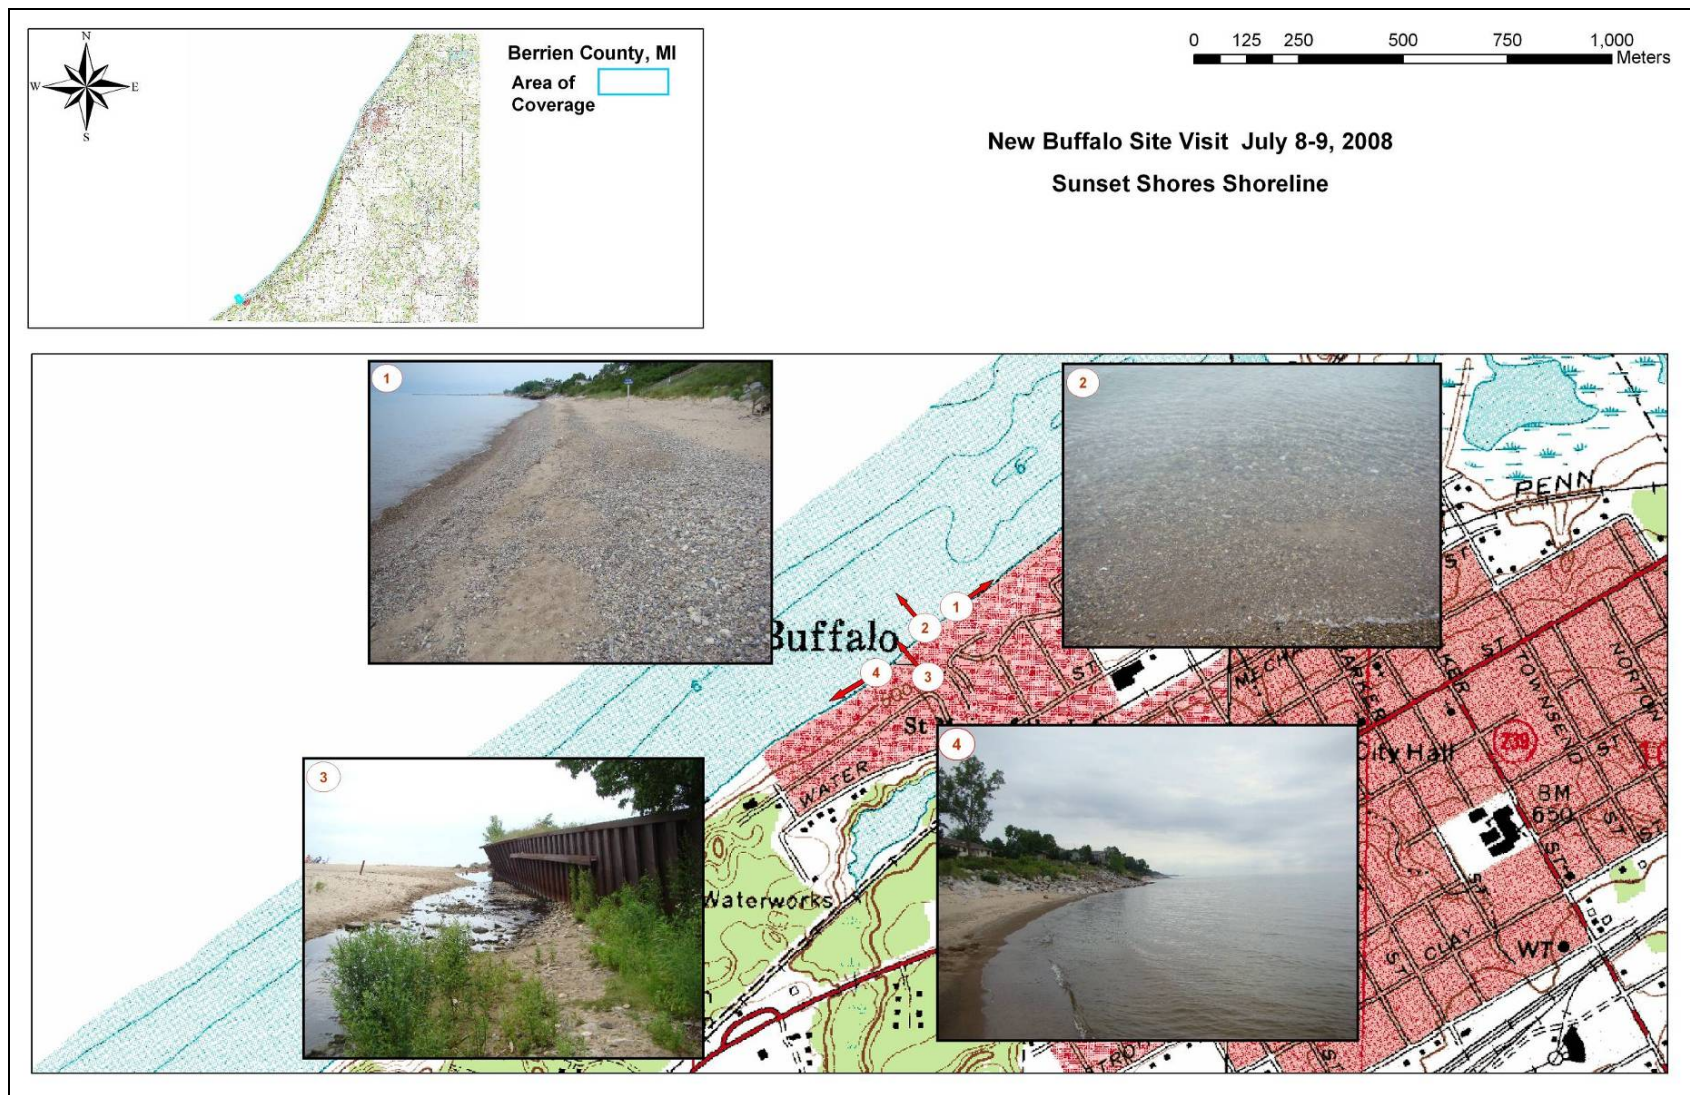
Figure 1.6: Photo Locations from July, 2008 Site Visit – Sunset Shores

Sunset Shores is a 1/2 mile stretch of shoreline just south of the south accretion fillet. The beach can be described as a pocket beach and the beach at the water line is mainly composed of 1/2" to 3" diameter cobbles (Figure 1.6, photograph 1). The nearshore along the beach is also mainly comprised of this cobble material (photograph 2). The water treatment facility to the south seems to keep this material from making it to Warwick Shores to any substantial degree. The main beach is immediately backed by a rock revetment (photograph 4) for most of the shoreline. In a number of locations there is just rock revetment. On the north side of the shoreline there is a small creek adjacent to a seawall that is showing signs of failure (photograph 3). This shoreline can be characterized as an armoured shoreline. The natural movement of sand transported from beach to dune has been compromised in this stretch of shoreline.

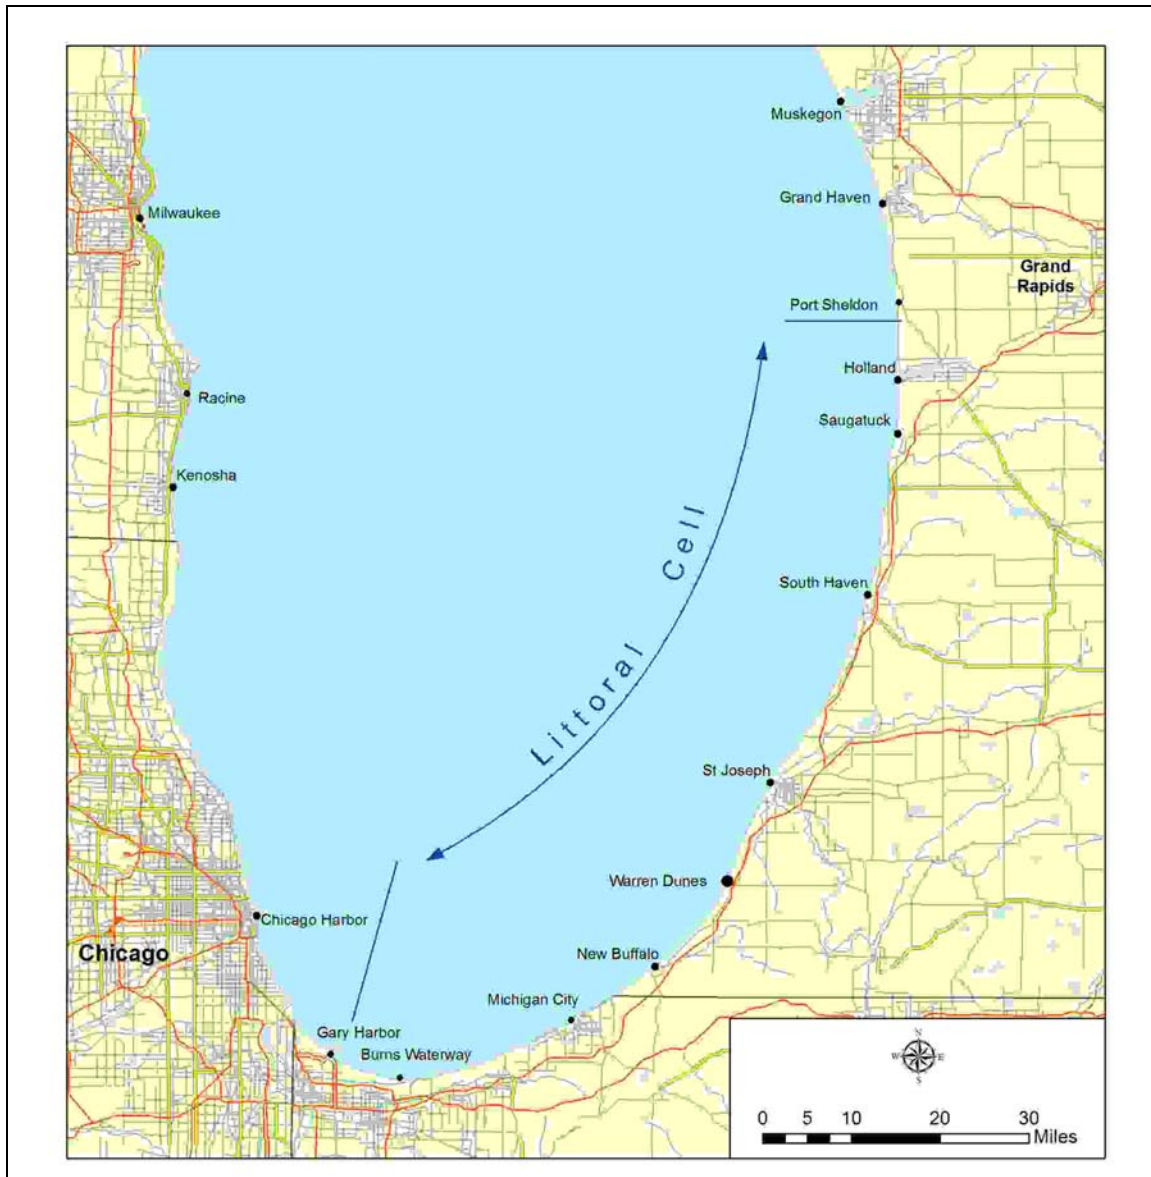
**Figure 2.1: Definition of Littoral Cell for Southeast Lake Michigan**

It is understood through these studies that the New Buffalo study area is a sub-littoral cell along the southeast shoreline and part of a much larger littoral boundary that extends from Port Sheldon in Ottawa County, MI to Gary Harbor, IN. The limits of this large littoral cell are presented in Figure 2.1.

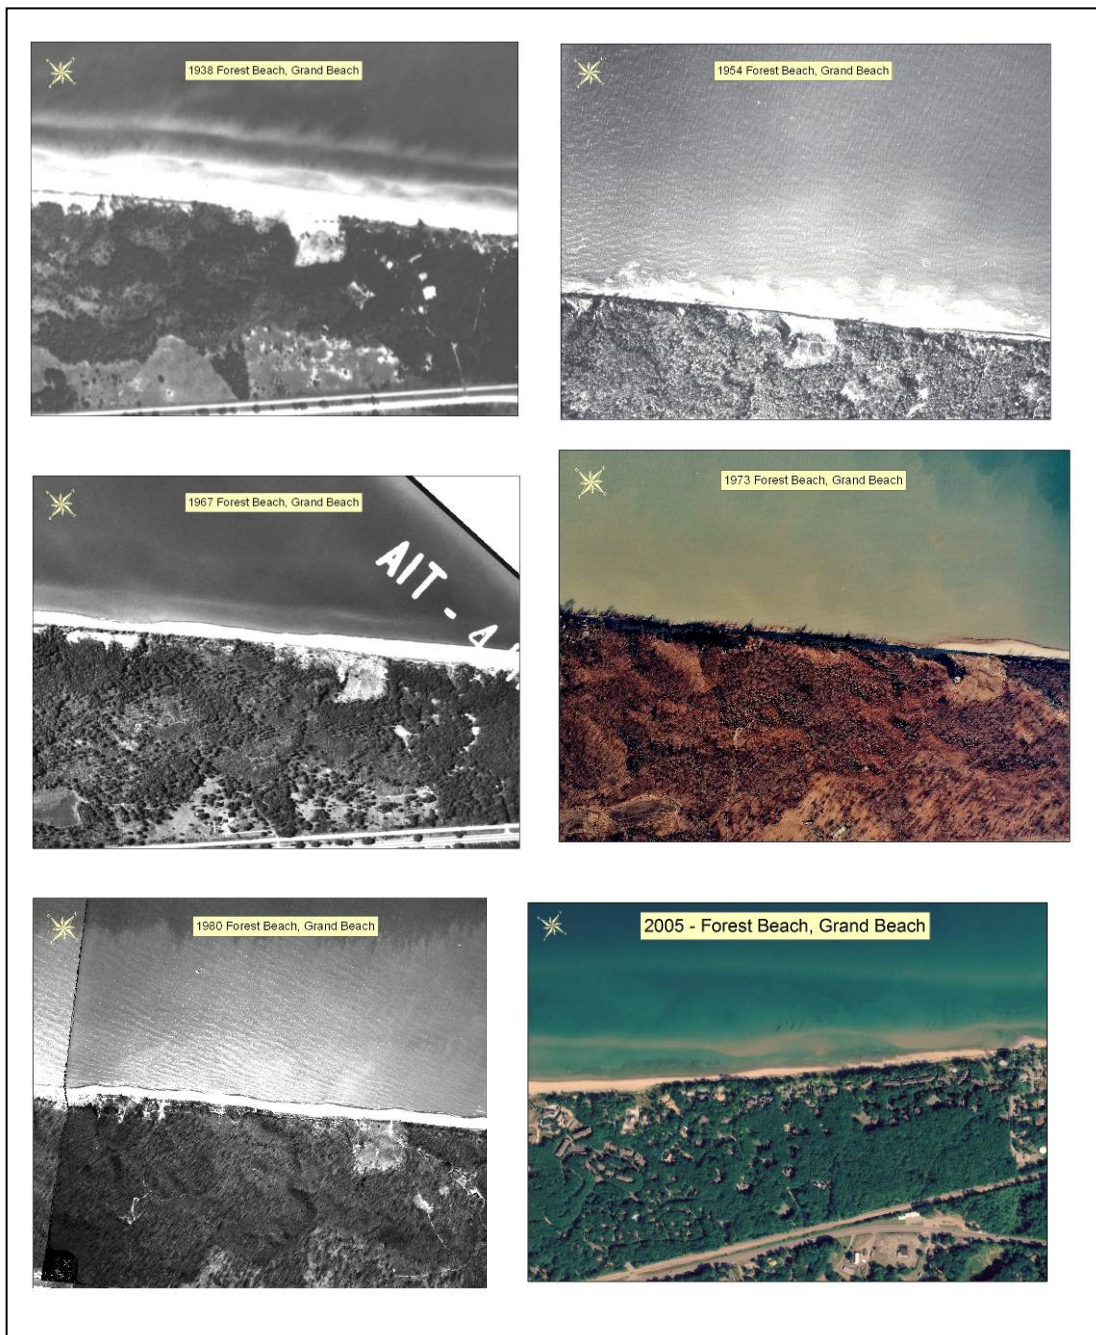
**Figure 2.3: Aerial History of Forest Beach and Grand Beach Area**

1938 aerial photography shows very little shoreline development for most of the New Buffalo region. The Village of Grand Beach area shows signs of development. A healthy beach and dune system in this stretch of shoreline is observed. The areas that are presently Forest Beach and Warwick shores look to be mostly wooded and with a significantly healthy beach and dune system. There are some access roads to the shore, but no residential development is observed at this time. The areas that are presently Sunset Shores and the south accretion fillet are very sandy areas with little vegetation and no development. The beaches seem very wide. The aerial photography appears to show exposed sand dunes in this area. The areas north of New Buffalo seem to exhibit more residential properties, similar to the Village of Grand Beach. The shoreline is well vegetated and sandy. There are no shoreline structures observed along any stretch of shoreline during this time period and no significant structures at the mouth of the river.

1954 aerial photography, when compared to the 1938 photography, shows more residential development in some areas and all the beaches are viewed as narrower. This may be attributable to the general rise in water levels between the two periods. The Village of Grand Beach area is more developed and less sandy. Shore protection in the form of groins and seawalls are observed on the aerial photography. Moving north to the Forest Beach area there is less development. Some groins and seawalls can be seen, but the area is mainly wooded. The aerial photography of the Warwick Shores area shows no development and exposed sandy areas and forest cover are observed. Development in the area of Sunset Shores has started, and there are a couple of residential homes visible. Additionally, there is a sandy area seen in the 1938 photograph which now has roads going through. Roads can also be seen in the south accretion fillet area, but no real development has started. The mouth of the Galien River does show a jetty along the north edge and a revetment to the south. The areas north of New Buffalo are observed as relatively the same as they were in 1938 with less forest cover and thinner beaches.

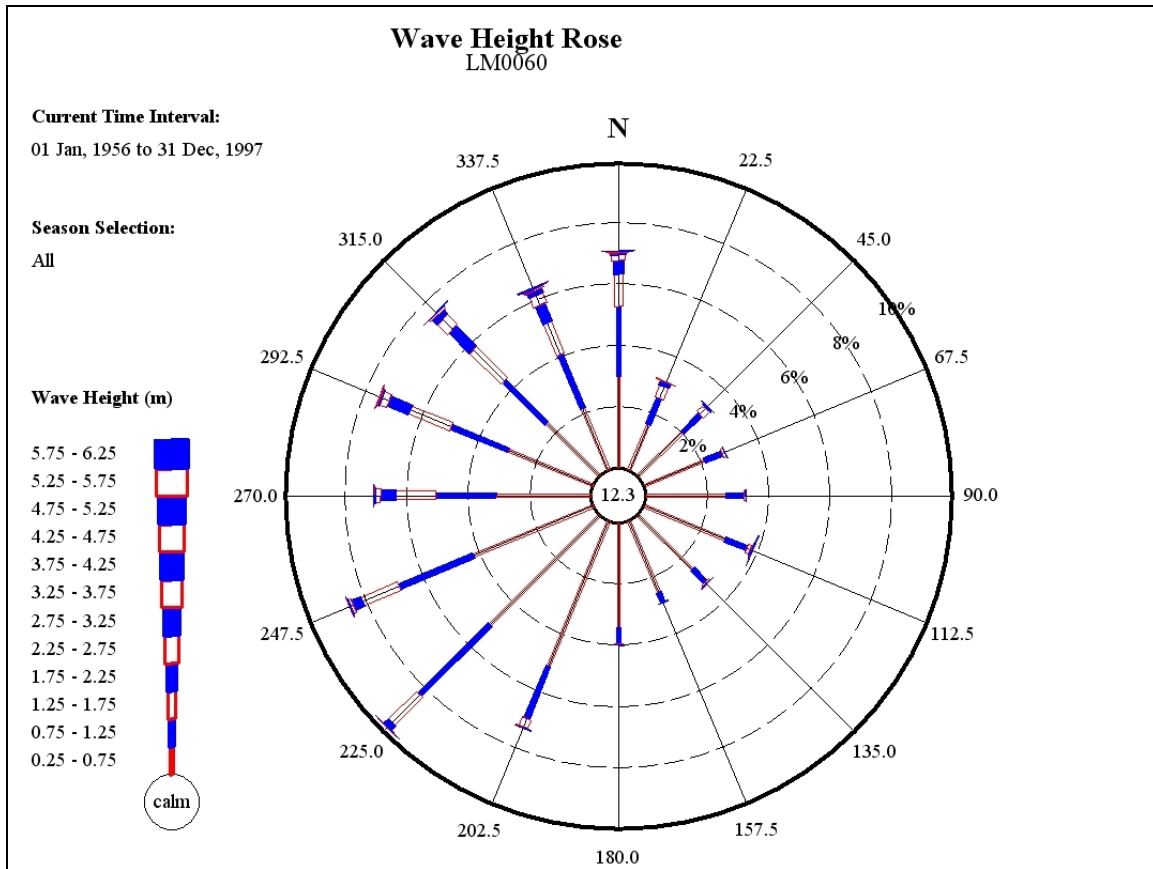
**Figure 4.2: Percent Occurrence of Wave Heights based on Direction**

Referring to the entire period of record for WIS Station LM0060, it can be seen that waves for this region approach the shore from the north to the southwest. Figure 4.2 provides more detail of these percentages. It is critical to reduce these into percentages of wave heights from each direction and for various wave periods so that the numerical model utilized in this study can represent real conditions without excessive computing time.

There were a number of considerations used in this analysis. First, due to the orientation of the shoreline, only waves from the north-northeast to the west were considered. Waves outside of these wave angles are considered too oblique to cause significant sediment transport. Second, for each wave band that remained, wave heights were separated as a percentage of occurrences from its respective direction. Third, based on work accomplished at Michigan City, IN (Baird et. al., 2006) and the data at Station LM0060, wave periods were associated with wave heights and wave directions.

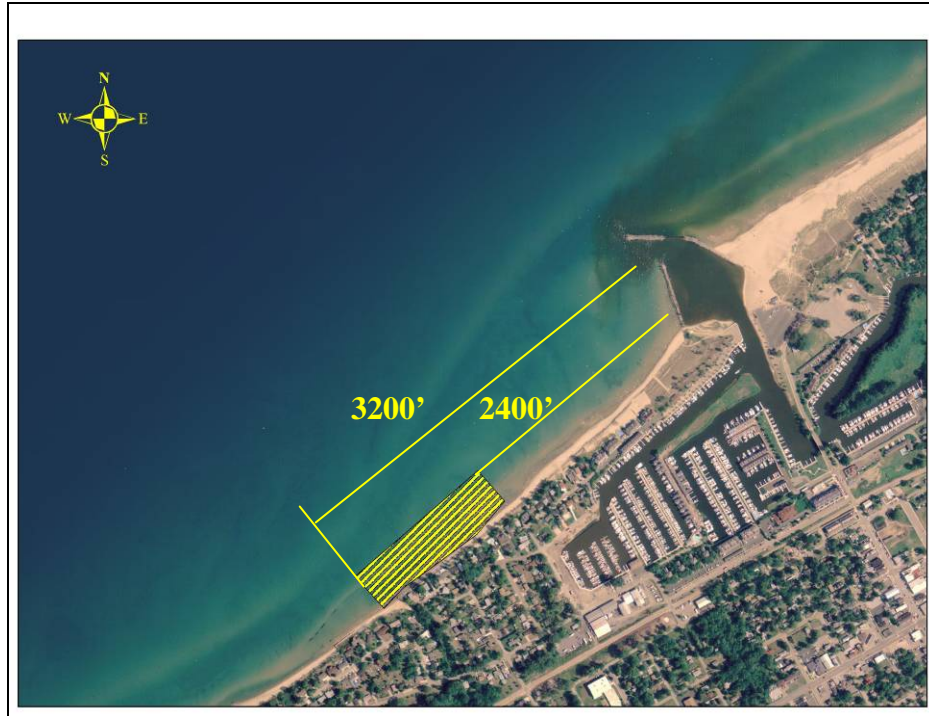
**Figure 5.1: Dredge Placement Area South of New Buffalo Harbor**

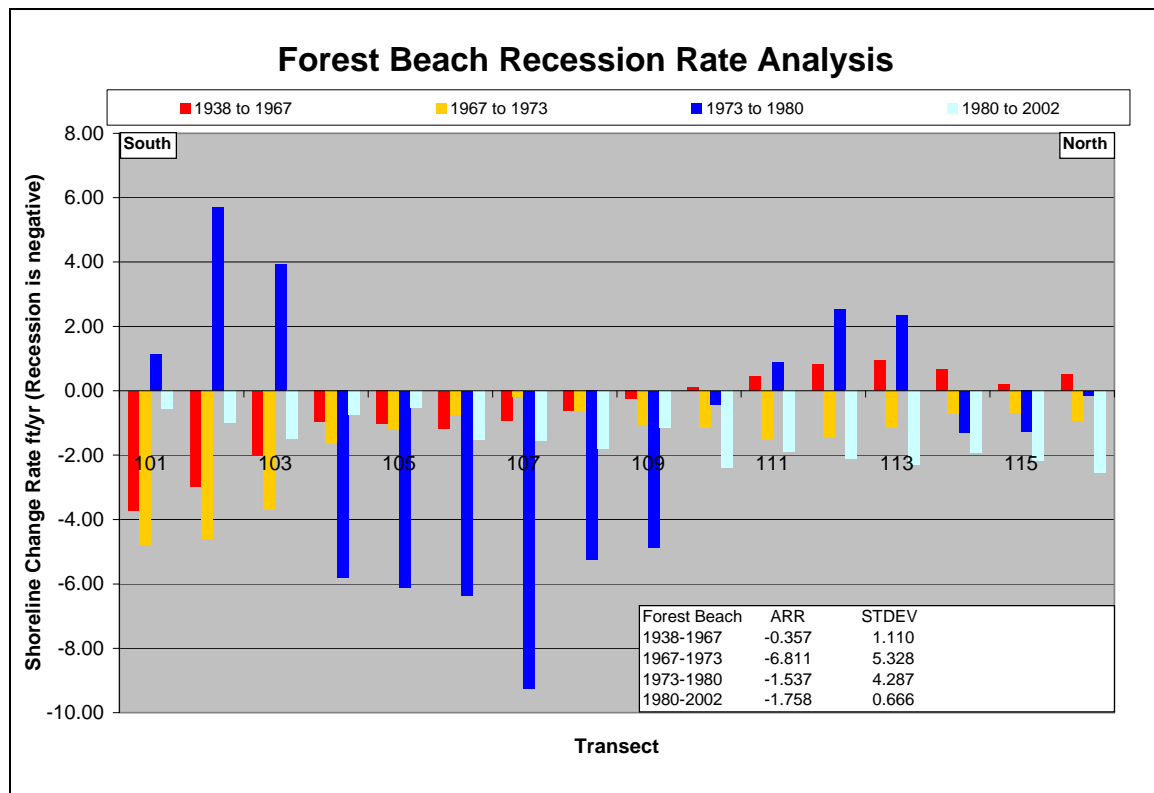
**Figure 6.3: Recession Rate Analysis for Forest Beach**

The Forest Beach shoreline is just north of Grand Beach. This shoreline stretches 2,500 feet along Lake Michigan and is represented by 15 transects. This shoreline has a slightly different history from Grand Beach. Most of the shoreline observed was relatively stable from 1938 to 1967. This changed drastically from 1967 to 1973 where the shoreline receded significantly. After 1973 the Forest Beach shoreline has remained relatively stable. Figure 6.3 shows that from 1938 to 1967 the ARR was about -0.358 feet/year. This increased significantly to -6.81 feet/year from 1967 to 1973. The shoreline continued to recede from 1973 to 1980 and from 1980 to 2002 at reduced rates of approximately -1.54 feet/year and -1.77 feet/year, respectively.

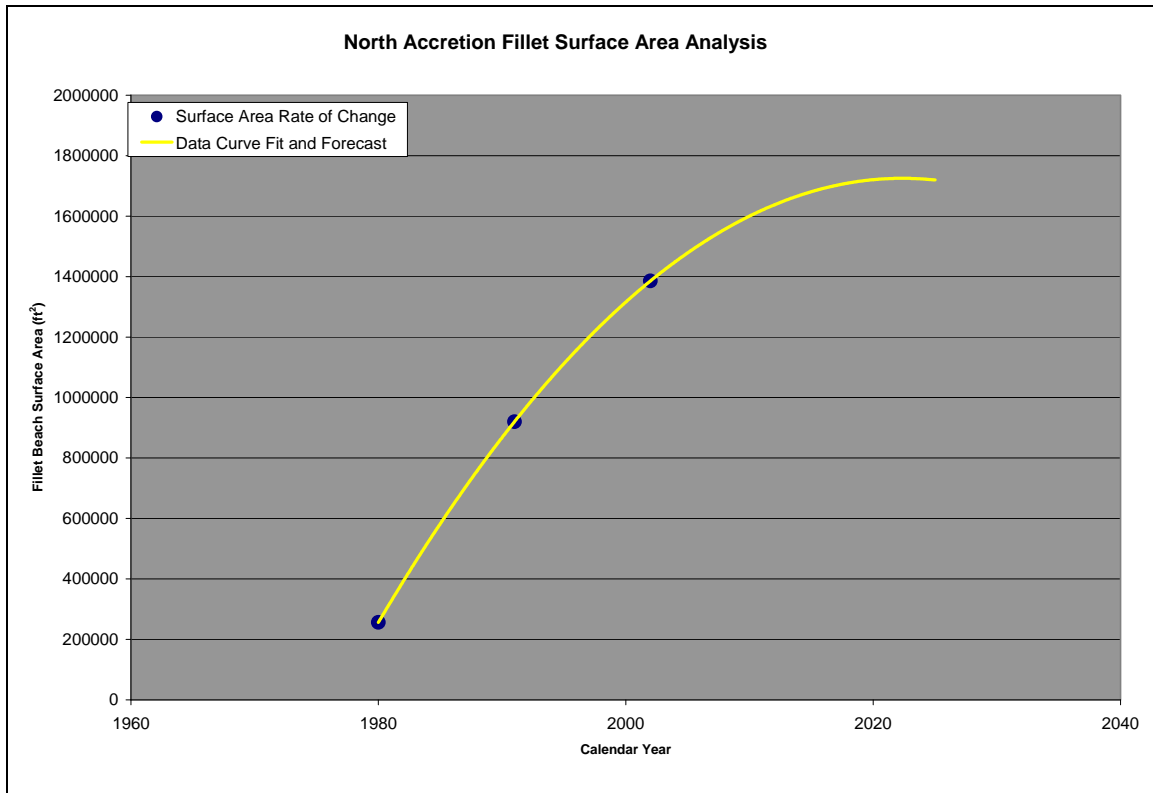
**Figure 6.10: Graph Representing the Growth of the North Accretion Fillet Surface Area.**

Taking the surface area values and graphing them over time shows that the north accretion fillet is probably still growing, while the south accretion fillet is more than likely at capacity. Figures 6.10 and 6.11 illustrate these conclusions. Figure 6.10 shows how the north accretion fillet has grown over the last 30 years and provides a forecast of what it is expected to do over the future.

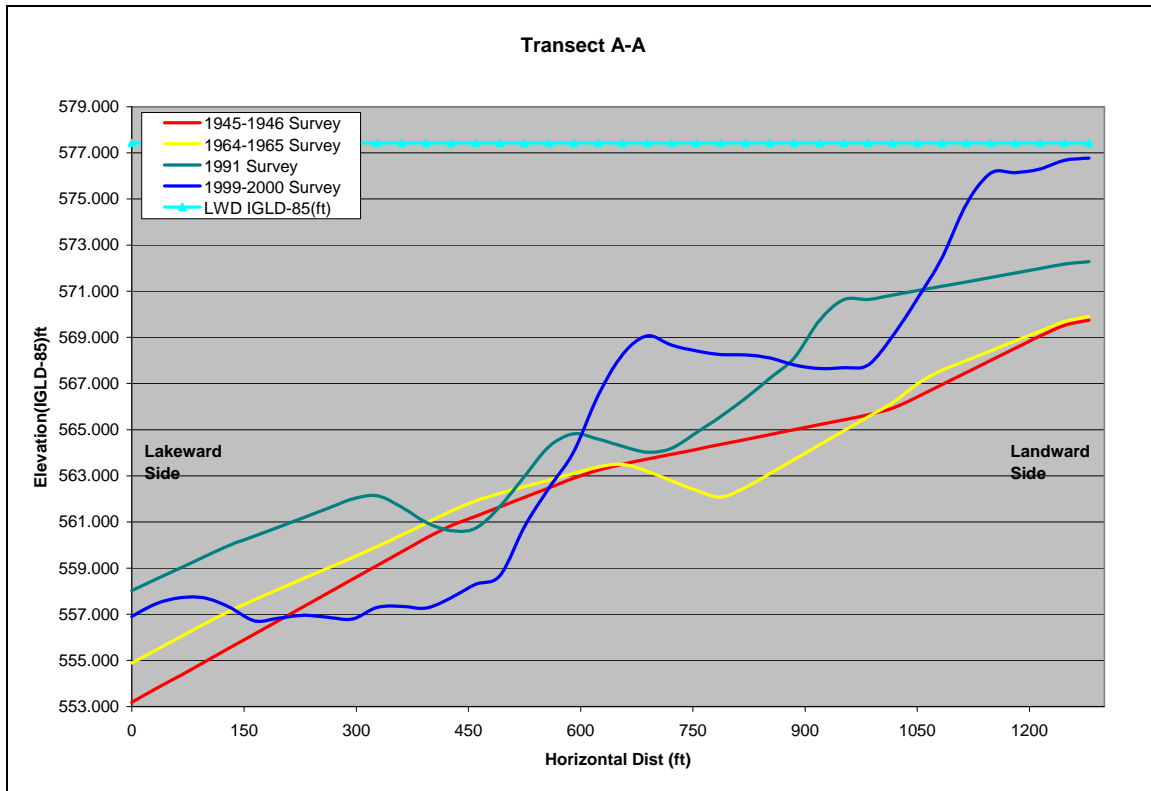
**Figure 6.13: Transect A-A Just North of Harbor.**

Figures 6.13 to 6.15 display the data from each transect. Transect A-A clearly shows the growth of the bypass bar between 650 and 850 feet, which is roughly at the end of the northern breakwater. As would be expected, the bypass bar loses some form (Transect B-B) as sand bypasses the harbor and is affected by dredging projects. As the bypass bar passes the harbor (Transect C-C) it gains its form again at the 650 to 850 feet location.

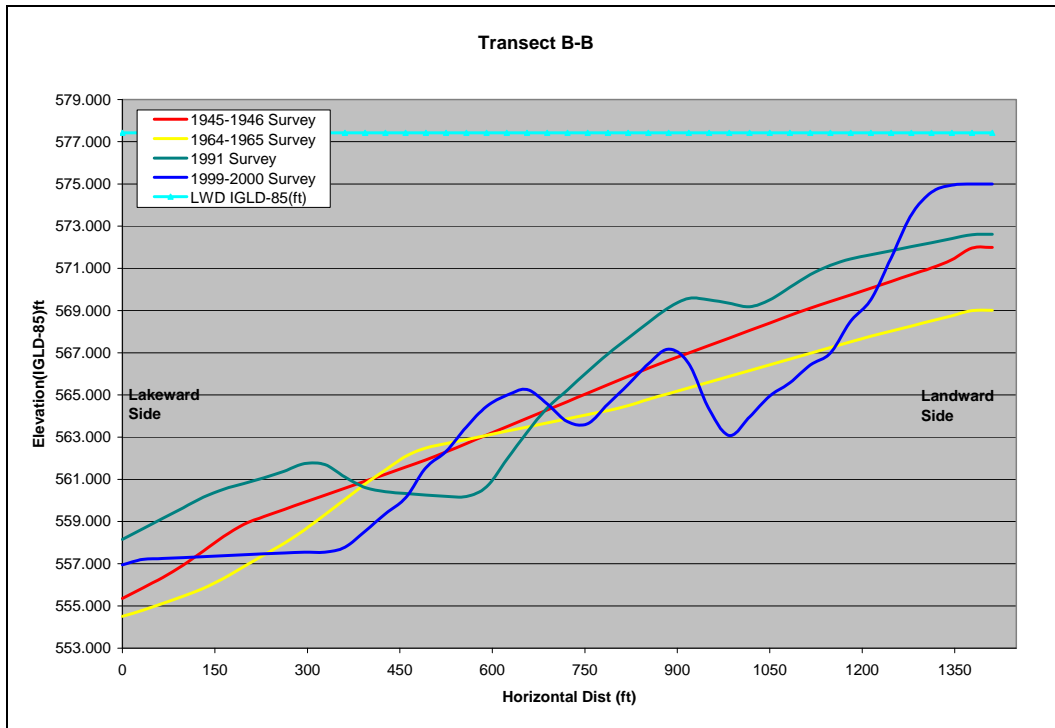
**Figure 6.14: Transect B-B In Front of Harbor.**

Some other interesting observations from the profiles can be seen from this data. First, the bypass bar is observed to react to water levels similarly on both sides of the harbor. When comparing the 1991 data with the 1999-2000 data, the bypass bar moves lakeward with lower water level and landward with higher water levels. (Note: Both the 1945-1946 and 1964-1965 data do not have enough resolution to provide sand bar location, only general lake bottom positions.) In addition, a significant amount of sediment either moved south or north from in front of the harbor (Transect B-B). Finally, it looks as though the lake bottom in the deeper portions of the nearshore has deepened significantly since 1945-46 for the transects north and south of the harbor. It is unclear why this occurred. Significant change occurred from 1945-46 to 1964-65. This process seemed to stop after 1965, with local shifting of the sand bar occurring in 1991 and 1999-2000. This process seemed to begin prior to installation of the harbor in 1975 and may be related to the removal of the railroad piers seen in the 1857 survey. These structures had created accretion fillets in the area. Once they were removed, the sand that was trapped around them may have taken time to redistribute. This could also explain how the river mouth location in 1857 was filled with sand as it is today. However, at this time there is no information on the removal of these structures that could support this hypothesis.

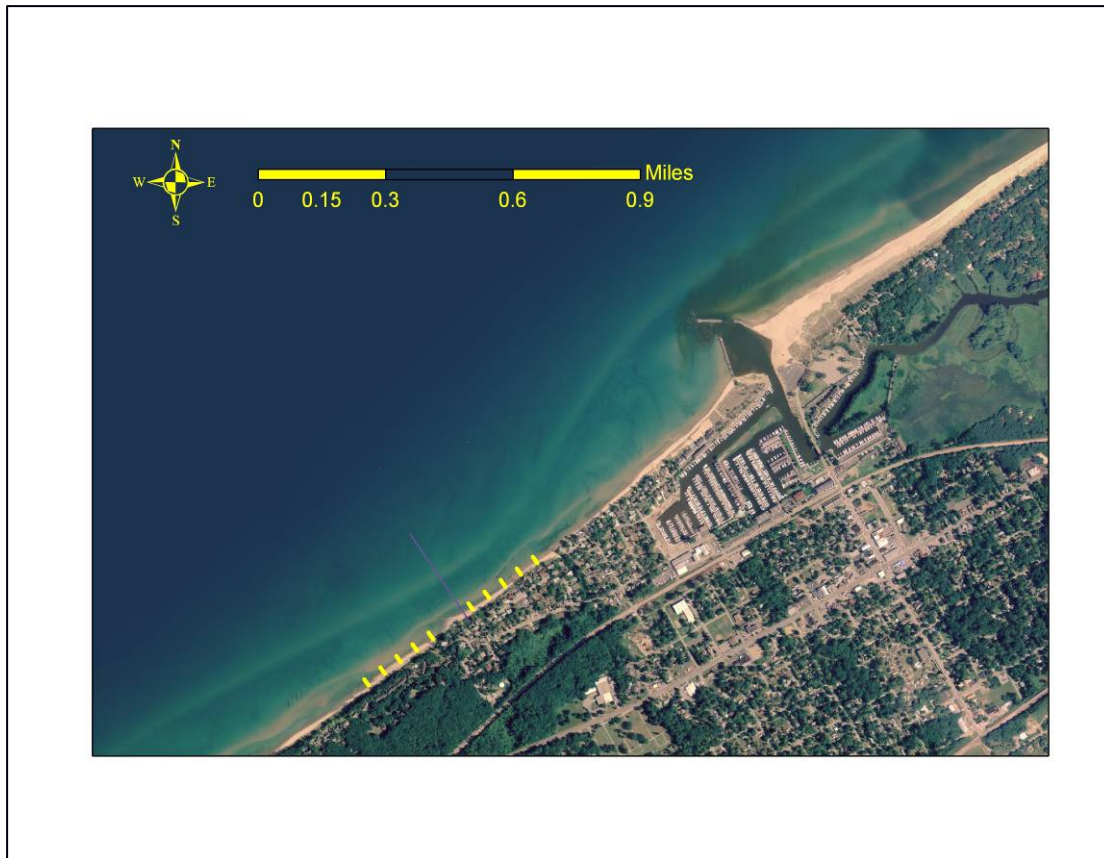
**Figure 8.8: Illustration of Groin Field Placement South of New Buffalo**
